AFWAL-TR-86-2015

ADVANCED HIGH-POWER GENERATOR RESEARCH PROGRAM

MAY 1986

FINAL REPORT FOR PERIOD JANUARY 1984 - OCTOBER 1985

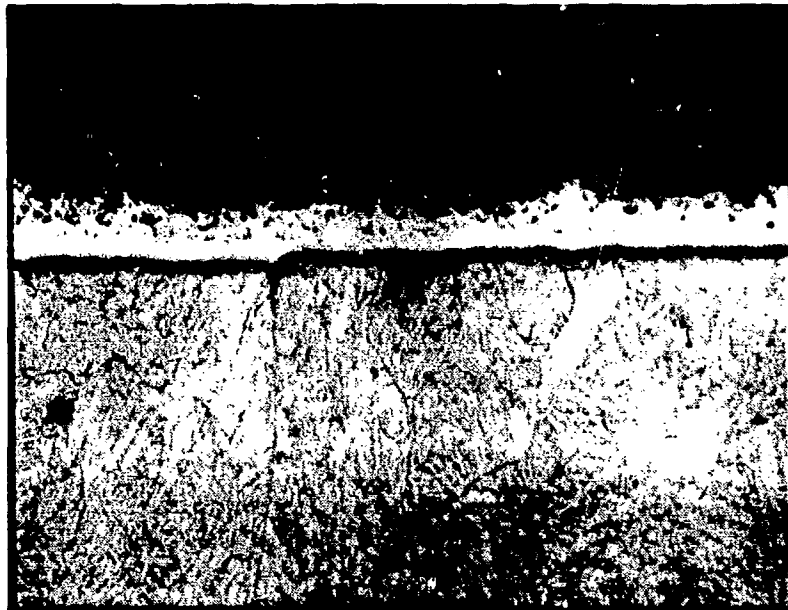
Micros were also made through several failed tensile specimens. Failures occurred within the Inconel 718 carbide precipitation zone.

Figure 3A-8. Typical Tensile Rupture. Failure Occurred within Inconel 718 Carbide Precipitation Zone. Magnified 225X.

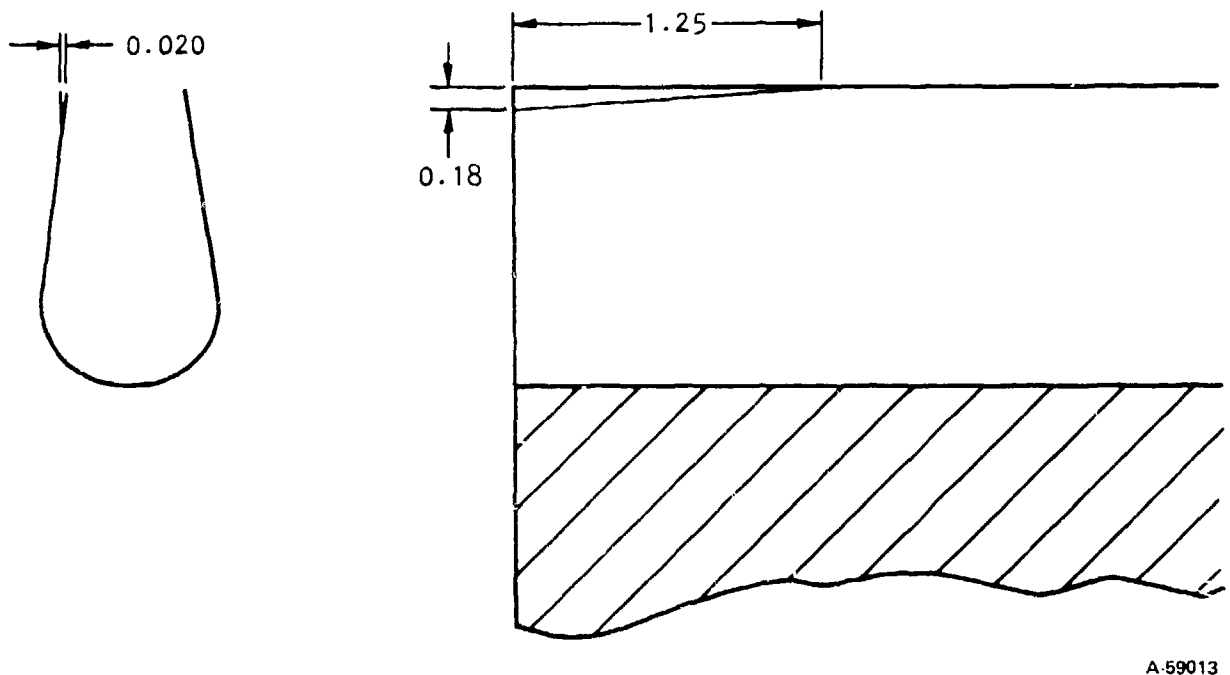
A flat spot was discovered on the No. 1 slot during inspection (see Figure 5-4). No action was taken other than a check for magnet cracking during each spinup.

Figure 5-4. Flat Spot on Slot 1

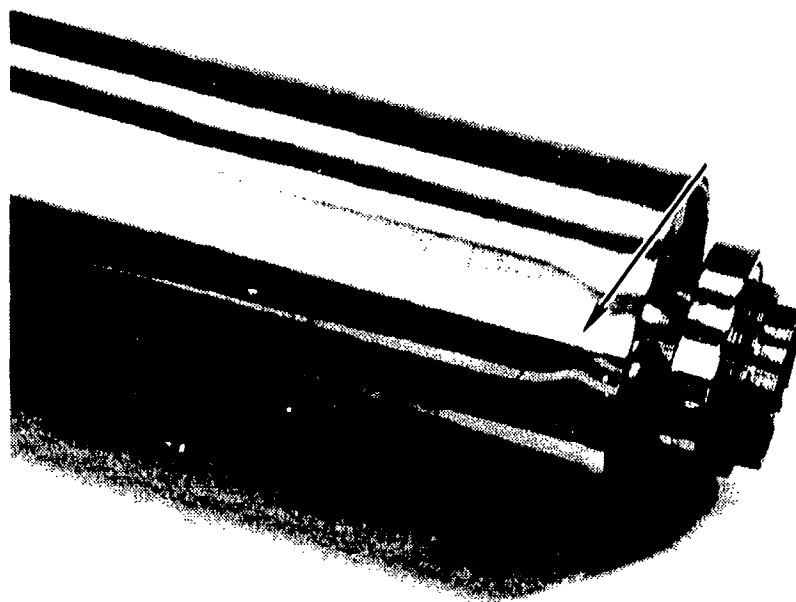
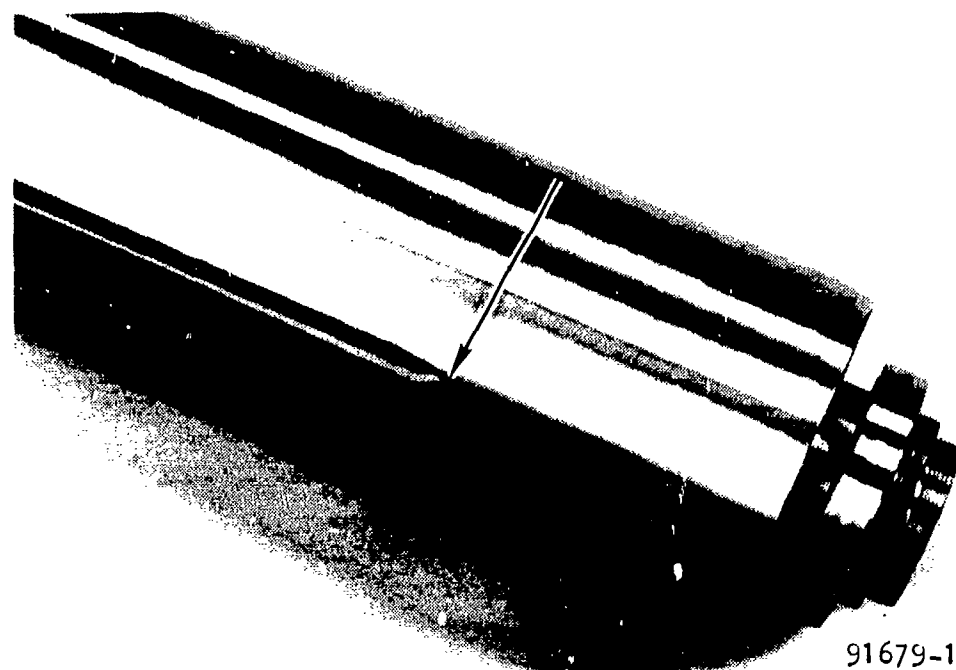
Figure 6-13. Two Views of Bumps Attributed to Magnet Separation

A small section of the sleeve was removed by grinding to determine the cause of one bump. A broken magnet was verified to be the cause. The sleeve was not designed to carry loading of the magnets. The sleeve was expected to deform, but appeared to be soft. Sections of the sleeve were removed and machined into tensile test specimens. Test results verified that the material was solution-annealed but not age-hardened. The sleeve-fabricating vendor had stated that the sleeve fabrication did not include age-hardening, but this fact did not reach the AiResearch engineering department. The second sleeve was age-hardened as a result of this discovery. Results of the tensile test for age-hardened and solution-annealed samples are shown in Table 6-4.

Prior to grind, the broken magnets pieces were removed and the depressions filled with Devcon F epoxy putty. Devcon F cures at room temperature.
